## LEAK DETECTION REPORT

Ref: Fictional example - Bay window and terrace infiltration (3B / 4B)

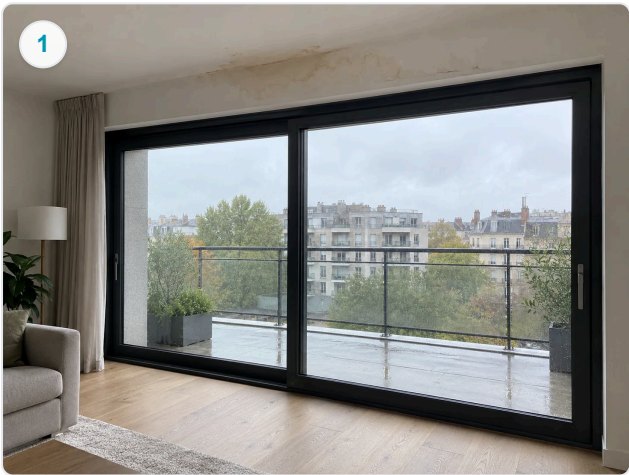
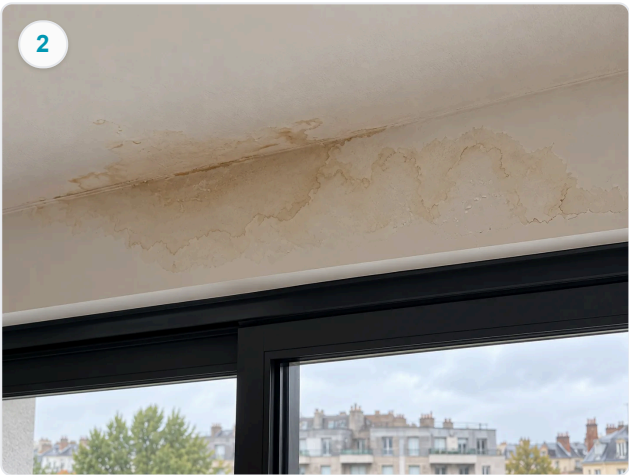
## Apartment 3B - living room, affected location

An irregular beige mark and slight paint blistering are visible at the wall-ceiling junction, above the sliding frame. No active water entry was observed during the visit. The marked area reads higher than a nearby reference area with the same instrument. This comparison helps locate the affected area but does not alone prove the water path.

The agreement between the affected area in 3B, the degraded seal at the 4B bay-window threshold and the response during the test primarily points to water ingress at this junction. The exact path through concealed elements was not observed. The source should be confirmed after remedial work.

1. Have a qualified contractor inspect and renew the waterproofing junction at the threshold and frame.
2. Check that the bay-window drainage is working and clear.
3. Carry out a targeted control test after the work, then monitor the drying of the affected area before repainting.

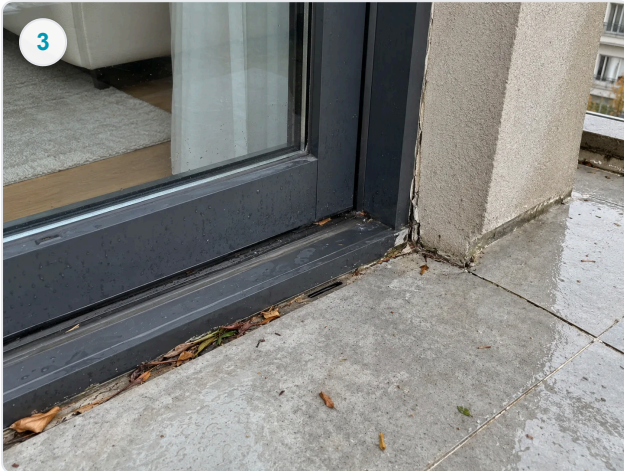
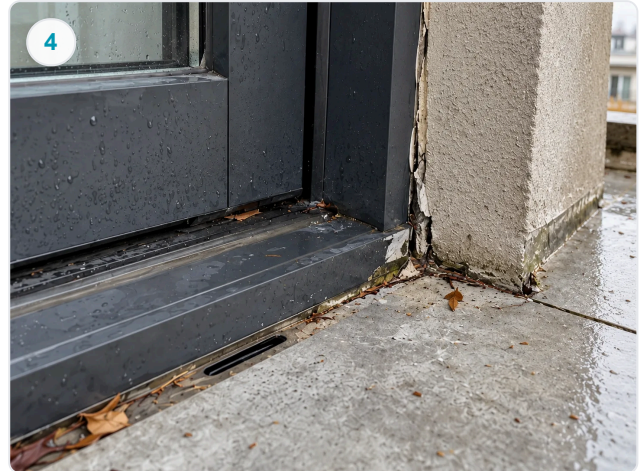
## Apartment 4B - terrace, presumed source

At the bay-window threshold, the perimeter seal is locally discontinuous where the right frame, threshold and render meet. Leaves and small debris are visible near a drainage opening. The photographs show the apparent condition of the junction; concealed waterproofing layers cannot be assessed without opening the assembly.
